DEPARTMENT OF TRANSPORTATION**DIVISION OF ENGINEERING SERVICES**

Quality Assurance and Source Inspection

Contract #: 04-0120F4Cty: SF/ALA Rte: 80 PM: 13.2/13.9File #: 1.28**WELDING INSPECTION REPORT****Resident Engineer:** Casey, William**Address:** 333 Burma Road**City:** Oakland, CA 94607**Report No:** WIR-027389**Date Inspected:** 30-Mar-2012**Project Name:** SAS Superstructure**OSM Arrival Time:** 700**Prime Contractor:** American Bridge/Fluor Enterprises, a JV**OSM Departure Time:** 1530**Contractor:** American Bridge/Fluor Enterprises, a JV**Location:** Job Site**CWI Name:** As noted below**CWI Present:** Yes No**Inspected CWI report:** Yes No N/A**Rod Oven in Use:** Yes No N/A**Electrode to specification:** Yes No N/A**Weld Procedures Followed:** Yes No N/A**Qualified Welders:** Yes No N/A**Verified Joint Fit-up:** Yes No N/A**Approved Drawings:** Yes No N/A**Approved WPS:** Yes No N/A**Delayed / Cancelled:** Yes No N/A**Bridge No:** 34-0006**Component:** SAS OBG**Summary of Items Observed:**

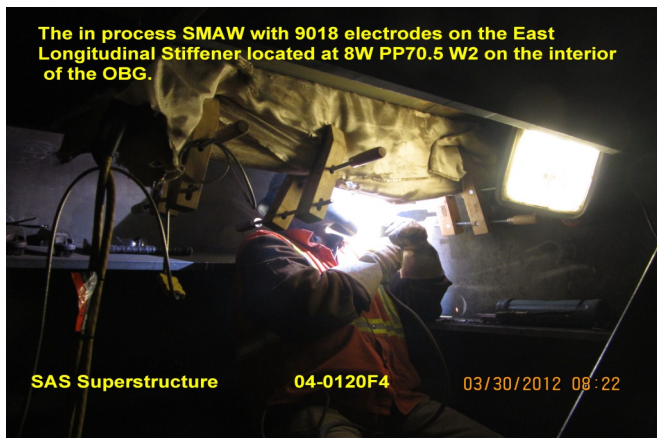
8W PP70.5 W2-LSE (Interior)

This QA Inspector randomly observed ABF welder Eric Sparks perform the Shielded metal Arc Welding (SMAW) process in the 3G vertical position on the East Longitudinal Stiffener (LSE) at 8W PP70.5 W2 on the interior of the OBG. QC Inspector Steve Jensen was present to monitor the welding and the parameters as they apply to ABF-WPS-D1.5-1012-3. Mr. Jensen informed this QA Inspector that the pre-heat temperature was verified and within compliance. This QA Inspector noted the use of the heat induction blankets and verified the temperatures to be within the acceptable ranges. The welder was observed utilizing the E9018-H4R electrodes required by this WPS and drew amperage of 138. On a subsequent observation, the welder was observed cleaning the work between passes while employing a small disc grinder blending the start/stop edges for a smooth transition. This QA Inspector made subsequent observations throughout the shift and noted that the work was ongoing and appeared to be in general conformance with the contract documents.

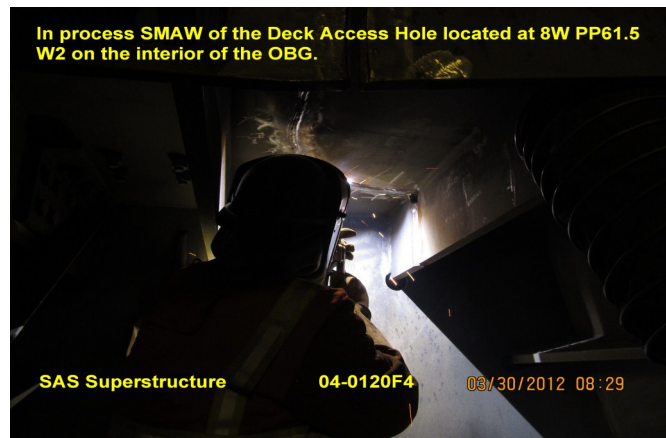
8W PP61.5 W2-DAH (Interior)

On random observations, this QA Inspector observed ongoing SMAW in the 4G overhead position on the Deck Access Hole (DAH) at 8W PP61.5 W2 on the interior of the OBG performed by ABF welder Mike Jimenez

(ID 4671). Mr. Jimenez was noted as grinding and blending the edges between passes utilizing a small disc grinder, brushes and compressed air. QC Inspector Steve Jensen Was observed monitoring the welding and the parameters as well as measuring the inter-pass temperature as they pertain to ABF-WPS-D1.5-1012-3. This QA Inspector verified that 9018-H4R electrodes were in use and that the baking oven was on and at the correct temperature. The parameters and the work at this location appeared to be in compliance with the WPS and the contract specifications and is ongoing.
